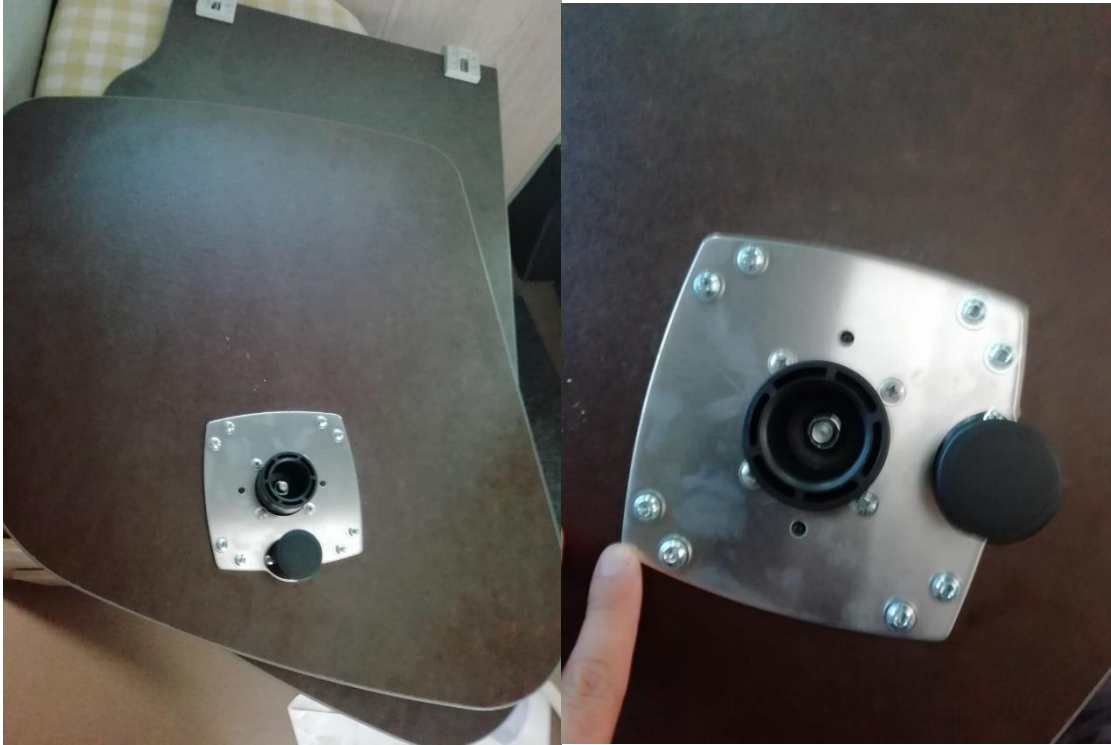
2-the extension of the dining table is blocked,

the technician has disassembled the table to put the closing spring correctly. He has also adjusted the pressure of the screw that acts as a closure.

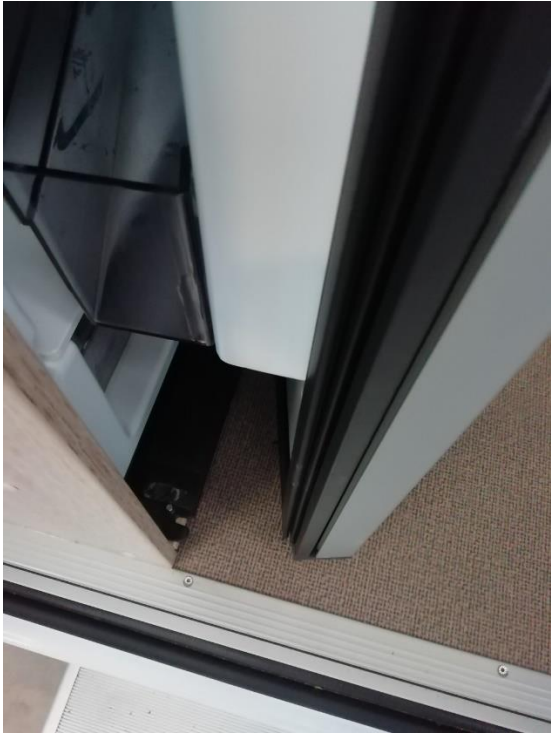
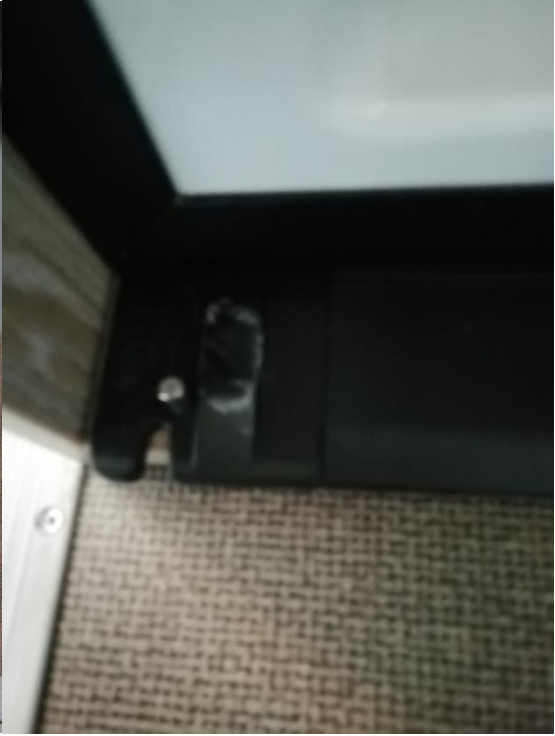
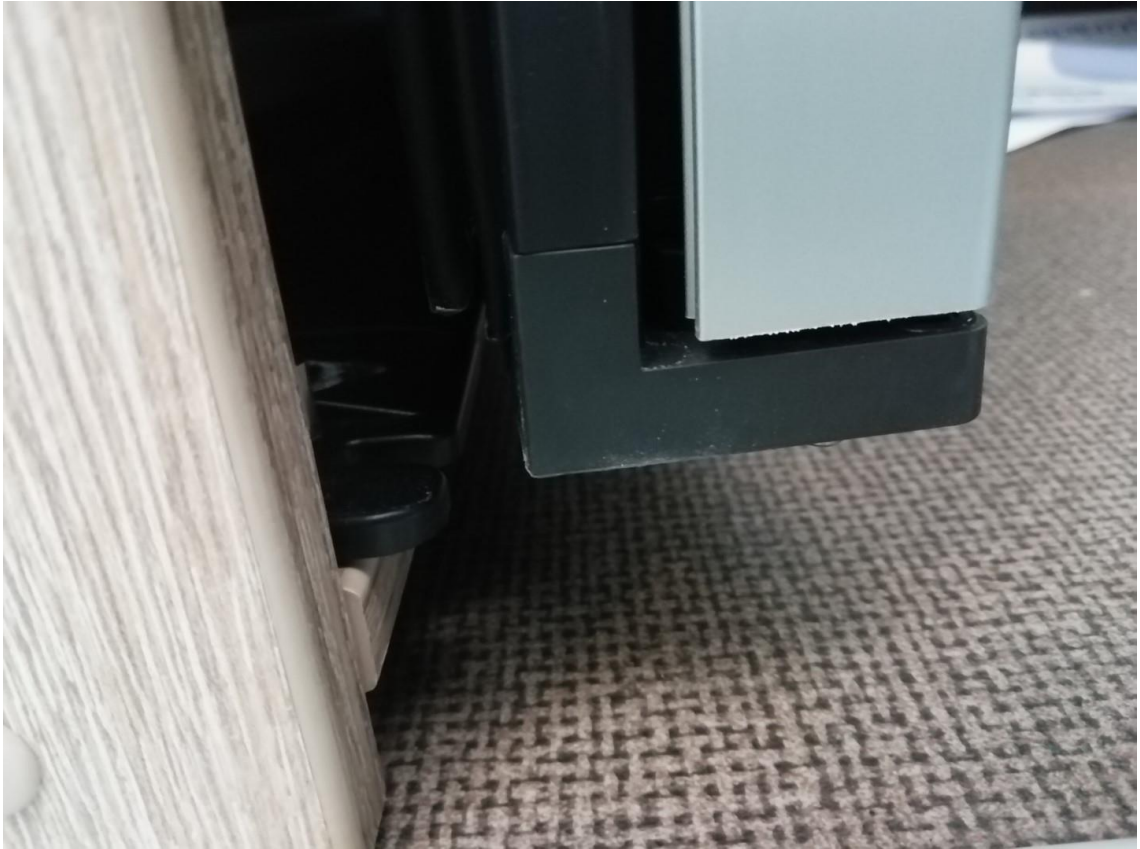
3-the refrigerator door touches the lower wood when opening,

The technician has removed the screws holding the fridge in place and lifted it up a bit at the front, then put a thick one under the front. Thus, it has been achieved that when the door is opened it does not touch the lower wood of the same structure.
