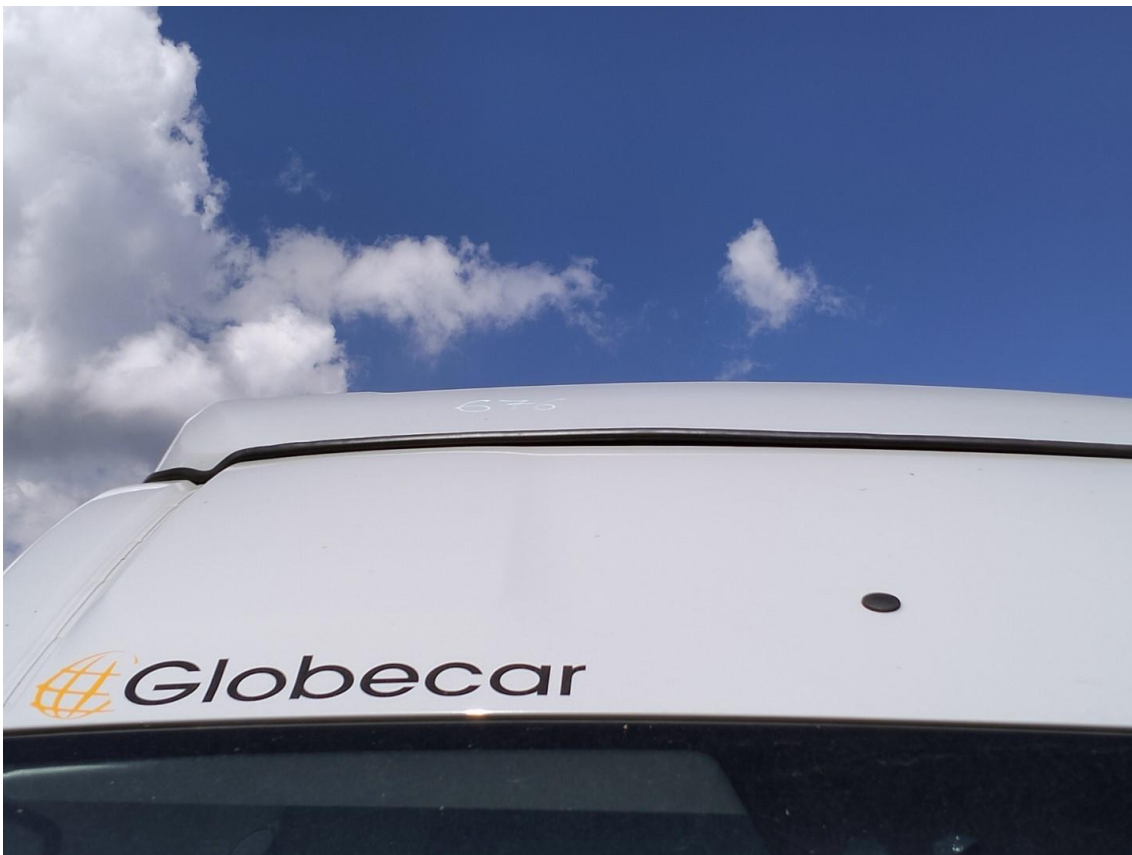
As reported in the delivery review, the base of the pop-up roof does not fit well and has a lot of separation distance.

There is a rubber band incorrectly placed to hide it, the technician has unhooked the joint, cleaned all the glue and placed the joint correctly, filling in the parts that had a difference in level so that it looks watertight.

Within the working time, material such as black sikaflex, cleaning material, polishing is included.
