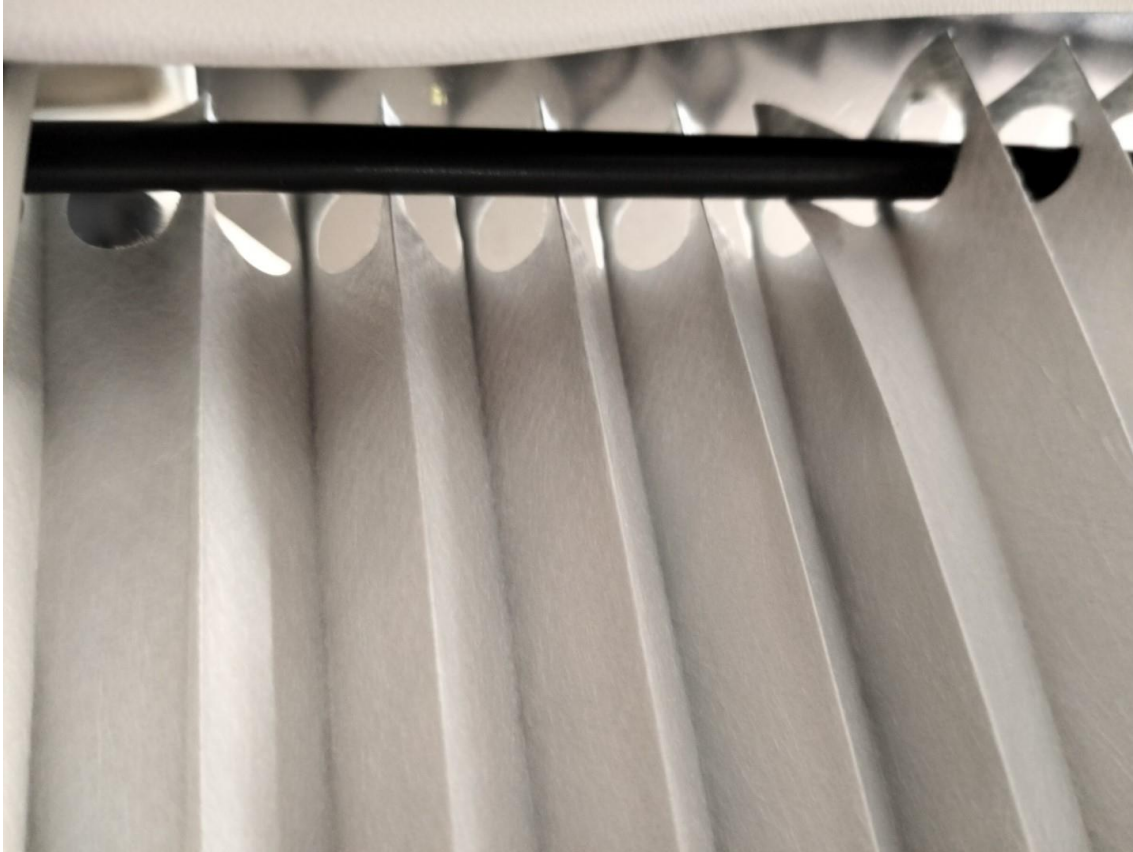
1-the windscreen remis, on the left side , is not correctly positioned on the upper guide, there are several holes without passing through the rod. the tencio has partially removed the Remis to be able to correctly insert the rod and pass through all the holes.

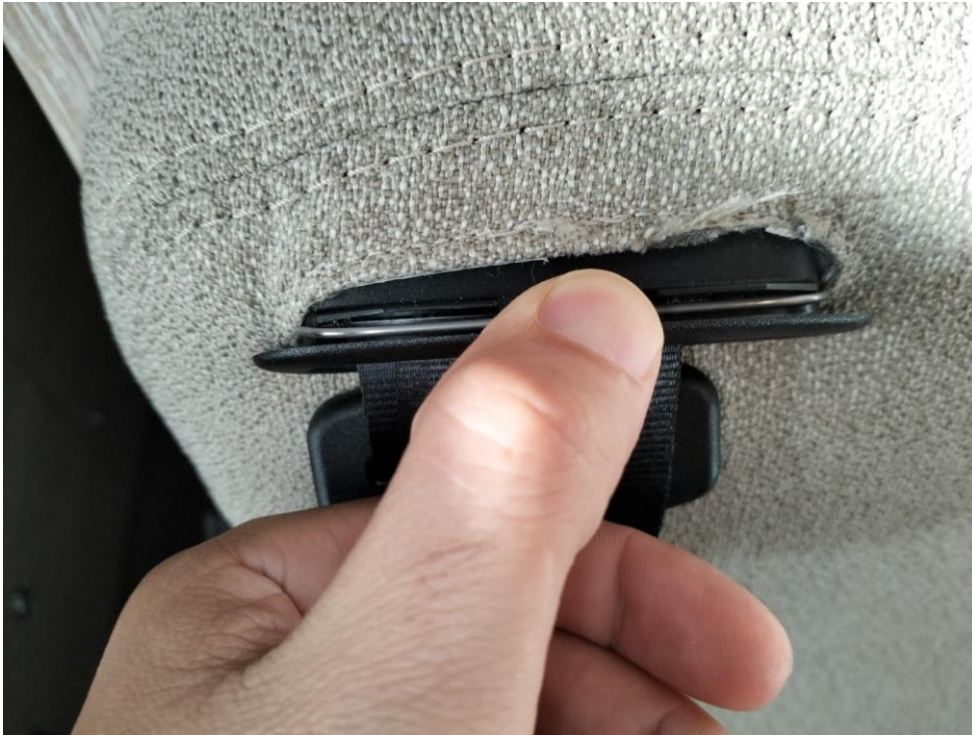
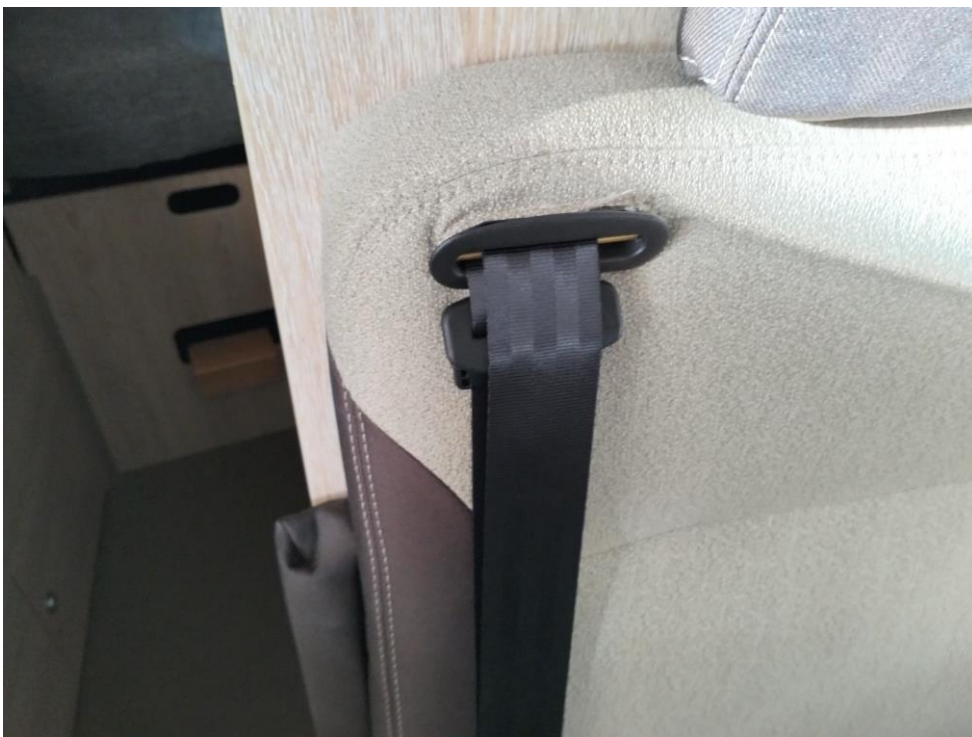
2-the belt protectors that go on the sofa are loose. The technician has had to disassemble them, clean the area and glue them again with stronger glue.

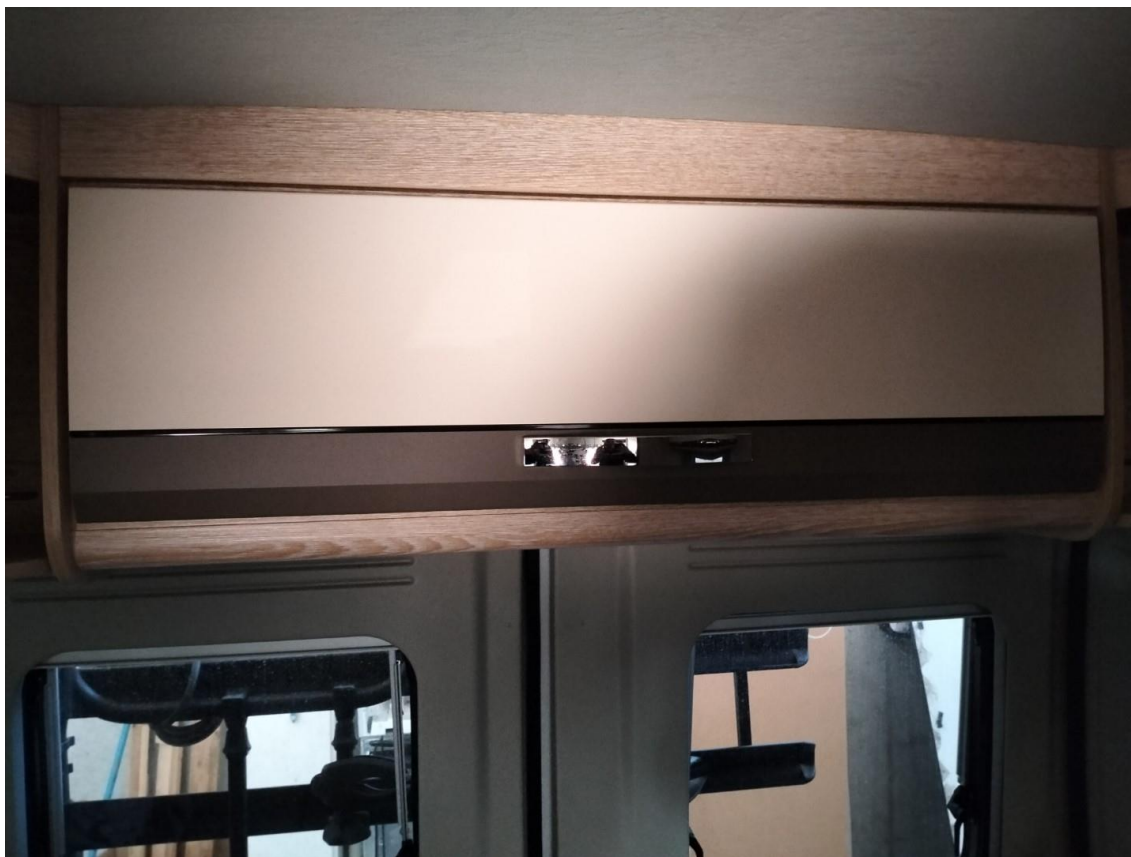
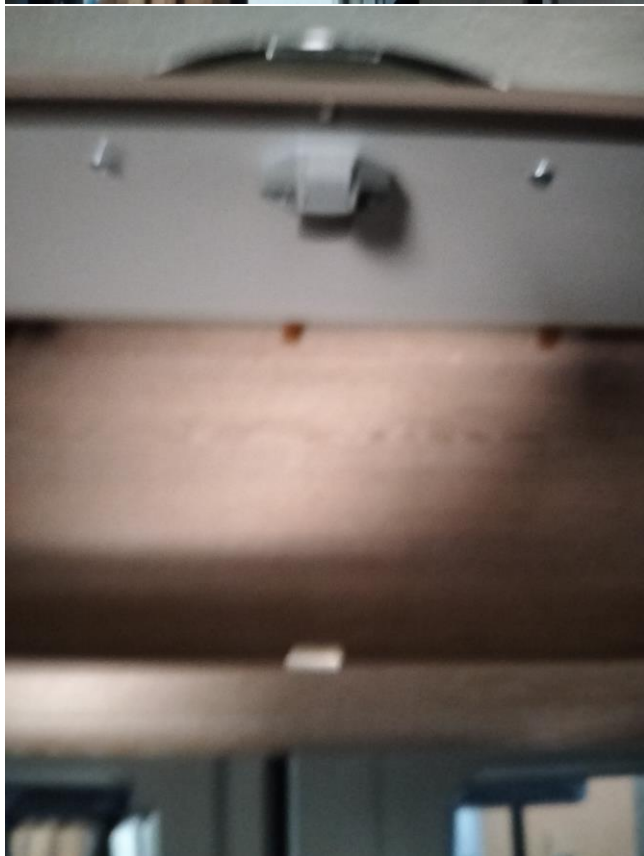
3-the rear cupboard above the bed cannot be closed. the tencico has had to adjust the closure and the hinges.
