ROADCAR 601- VF7YCBPFC12U33938-OT7490

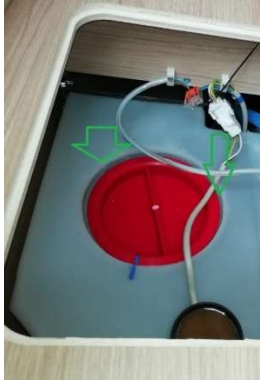
The customer complains that the fresh water tank leaks for the red cap this time. The technician has had to adjust the cap by sanding a little bit the mouth in order to adjust the cap correctly. and refill tank several times to check it

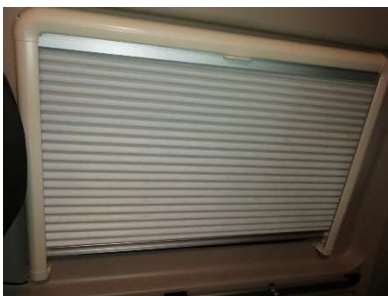
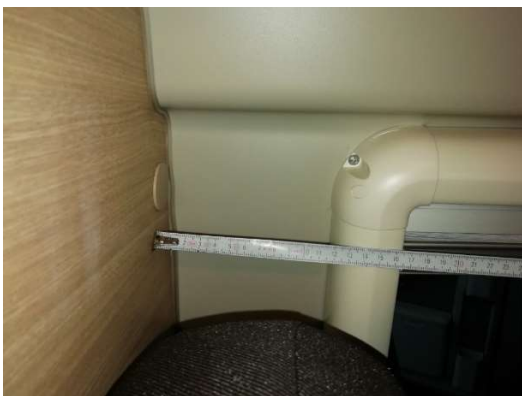
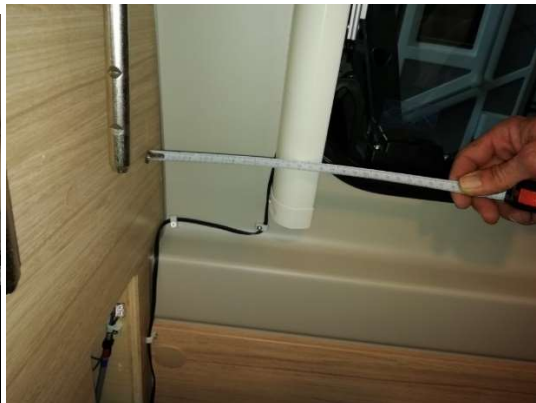
The customer complains that the combicassette from dinningroom is not centered. After checking the technician has noticed that the combicassete is 11,5 cms in lower area and 12 cms in upper area in comparison to the wall which makes it to look not straight. The technician has dismantled it and has centered it, and refixed again straightly. Also the same problem in the Toilet, sorry, in this last case I have not got the measurements specifically.

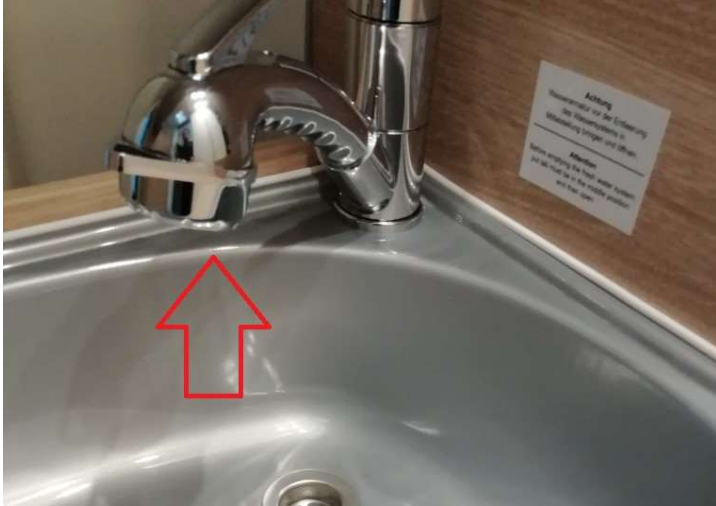
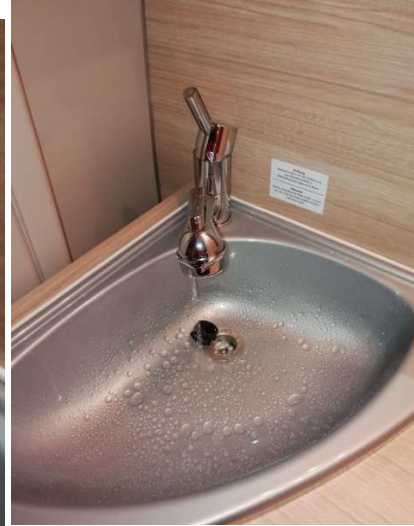
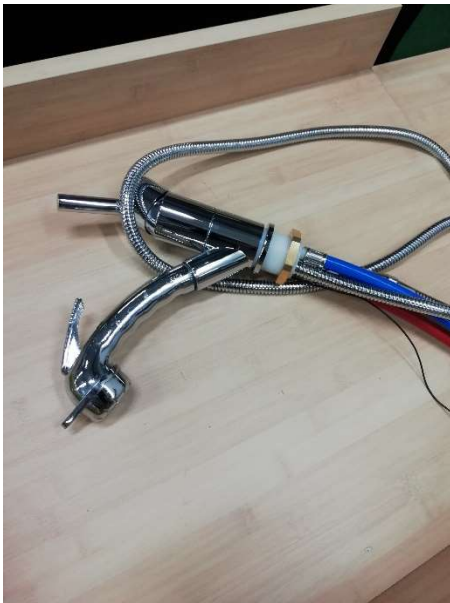
The customer also complains that the toilet tap which is also a shower tap does not work correctly. The hot water does not activate the water pump only the cold water. The technician has had to replace the tap because it is not a correct function, the switch fails
